Overhauled gas drainage drill rig

A unique capability, Berendsen successfully carries out gas drainage drill rig overhaul for underground coal mine

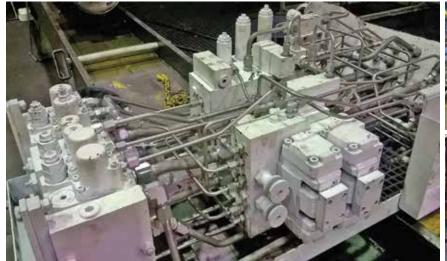
Condition of gas drainage drill rig prior to overhaul

The rig had been sitting idle on surface for almost 2 years, numerous components had gone missing and so a full mechanical and electrical overhaul was required to return the machine to service.

The overhaul process began with stripping the existing machine, establishing the scope and quoting the customer.

Berendsen Wollongong then repaired existing hydraulic components where possible and ordered and installed new components where required. This involved:

- Repairing and replacing hydraulic cylinders –
 Tilt and feed cylinders were overhauled and track tension cylinders were supplied new and installed
- Welding the structure where it had been damaged or where welds had cracked
- Cleaning the tanks
- ✓ Replacing the hoses and stainless pipework
 All of the hydraulic hosing and stainless steel pipework was supplied new and installed compliant to MDG41.
- ✓ Repairing the gearboxes, pumps and motors – Including crawler motors and gearboxes, 2 axial piston pumps, 2 gear pumps, a rotation unit motor and gearbox
- ✓ Replacing other parts that required replacement Including track components such as track chain and rollers, track idler springs, heat exchangers, valves, accumulator and all wear plates and slides
